# Remote Handling JET Experience

A C Rolfe.

JET Joint Undertaking, Abingdon, Oxfordshire, OX14 3EA,

Preprint of a Paper to be submitted for publication in Nuclear Energy

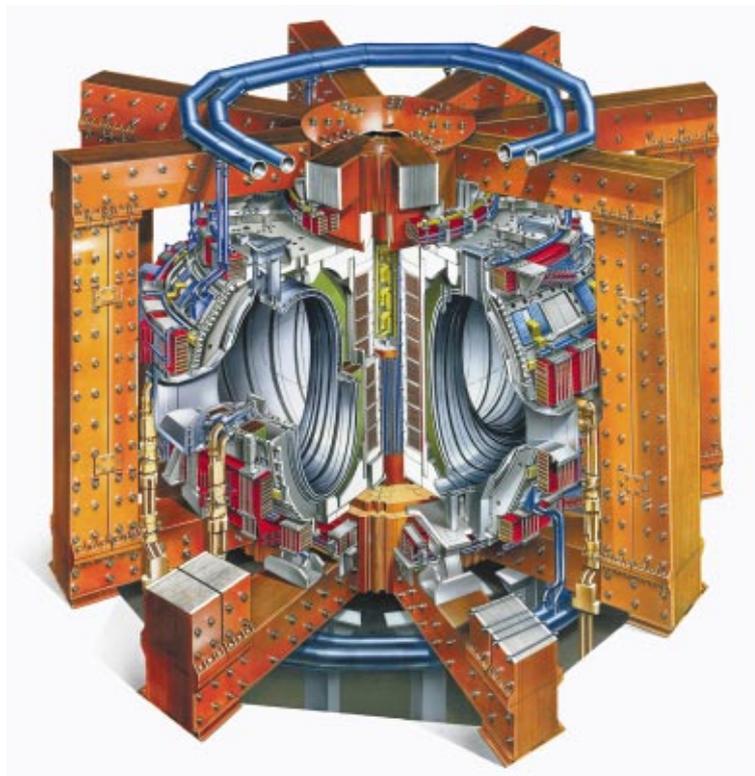
The Joint European Torus (JET) project is the world's largest experiment to study the physics and technology of energy generation using nuclear fusion. The experimental machine, a Tokamak, comprises a toroidal vacuum vessel of 3m major radius inside which a plasma is heated to temperatures of up to 450million degrees, figure.1.

*Figure 1 JET Tokamak*

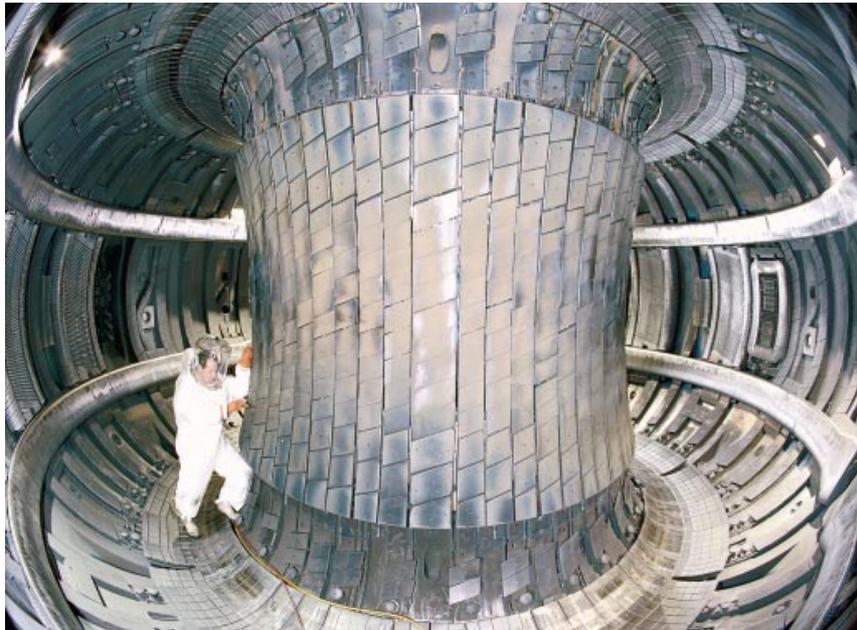
*Figure 2 Inside the JET Torus in 1985*

The components on the inside of the torus in the early 1980's, fig.2, have since been changed a number of times and in 1997 had the configuration shown in fig.3. A similar transformation has taken place on the outside of the torus. Throughout this period the Fusion experiments have been carefully limited to ensure that all of these changes can be effected by manual means.

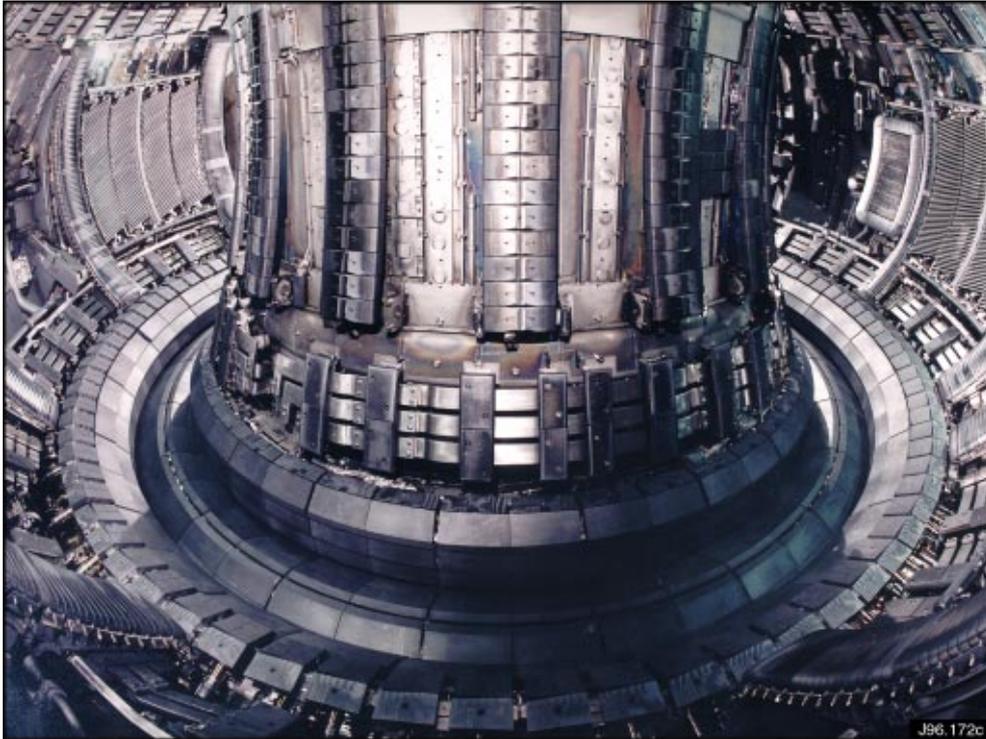
*Figure 3 Inside the JET Torus in 1997*

During late 1997 a series of experiments were performed using D-T mixtures and this resulted in an activation of the machine which prohibited manual access to the inside of the torus for around one year. The D-T operations resulted in an activation of the torus giving a background in-vessel dose rate of 4.5 mSv/hr at the start of the remote handling shutdown. Personnel working in this level of radiation would receive their entire JET annual allowed exposure within 1 hour. The JET experimental programme required that in early 1998 the divertor had to be replaced with an alternative configuration and the activation levels dictated that this modification must be done using only remote handling methods. The inside of the torus before the remote modification is shown in fig.3.

The divertor is a key system for controlling plasma impurity and can be seen as a continuous channel formed by tile surfaces in the lower part of the photograph. It was required to remove all 144 modules which form the divertor and to replace them with 192 new modules to create a new configuration as shown in fig.8.

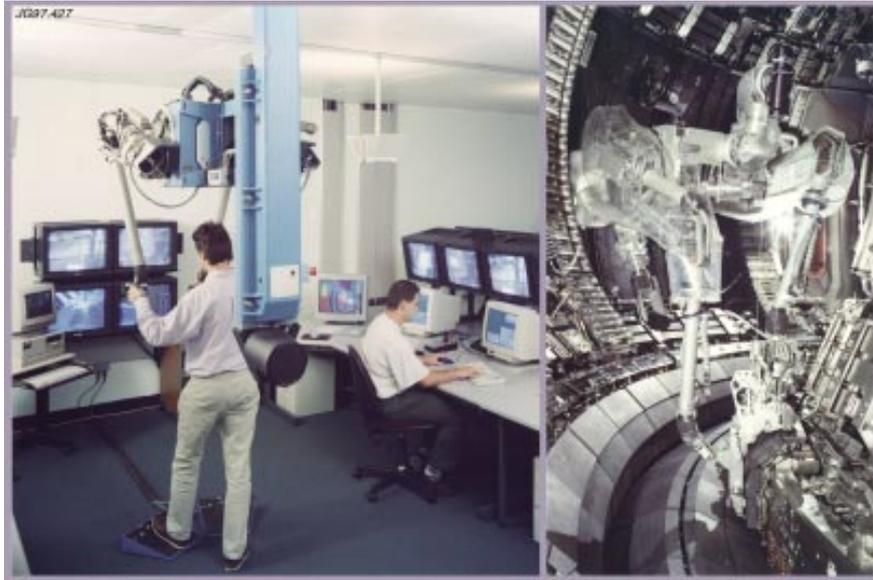
The objective of this approach has been to develop a method by which the skilled technicians who have previously assembled and normally maintain the Tokamak can continue to perform this function even when radiation levels prohibit their personal access to the work area. A remote handling system has been implemented which is based on deployment of a two arm, force reflecting, Master-Slave, servo-manipulator system which, together with the extensive video feedback, provides the operator with a sense of performing the work as if he were actually inside the torus, fig.4.

*Figure 4 JET Remote Handling Approach*

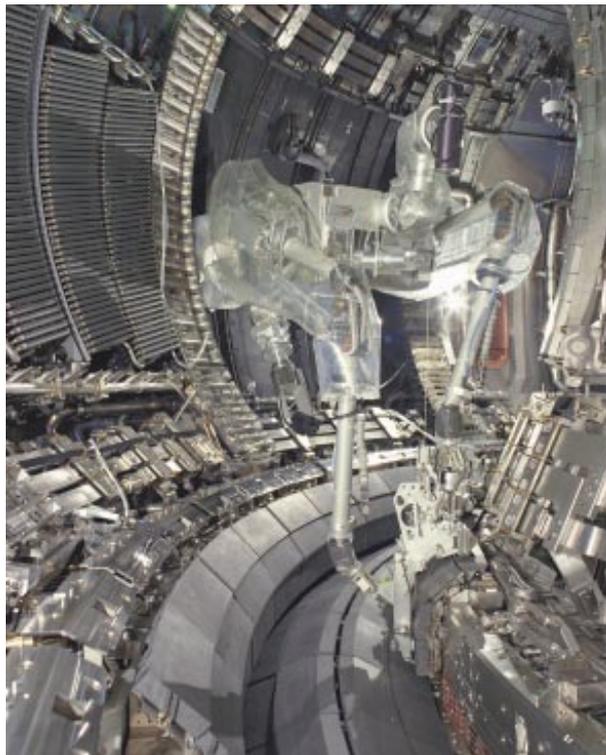
The servomanipulator device used at JET, Mascot /1/ and fig.5, has 7 degrees of freedom per arm, can be used to lift up to 20kg per arm and has a force reflection sensitivity of 100gm.

*Figure 5 Mascot Slave Operating inside the Torus*

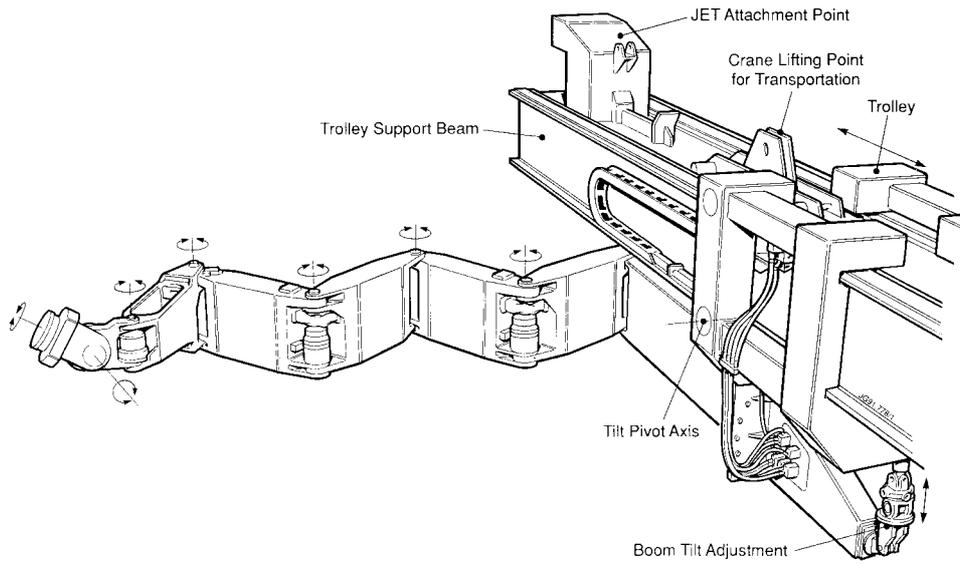
The Mascot slave is positioned inside the torus using a 10m long articulated boom, /2/ and fig.6. This device has 19 degrees of freedom and is controlled very much like a robot either from a joystick, a keyboard or using pre-taught sequences of motion.

Figure 6 JET Articulated Boom

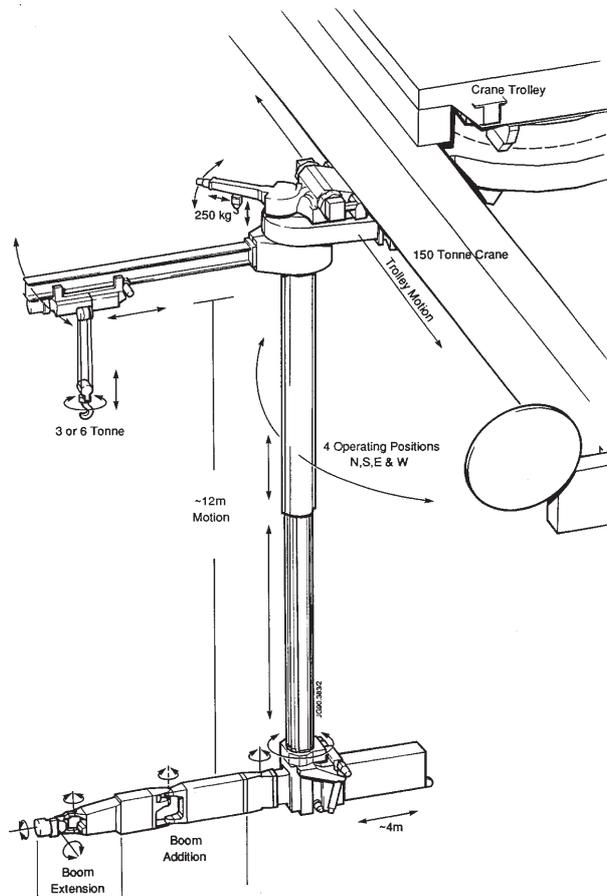
In order to perform tasks on the outside of the torus the Mascot is positioned using the Telescopic Articulated Remote Mast (TARM), /2/ and fig.7. This device has 29 degrees of freedom and a 66500m<sup>3</sup> operating envelope making it one of the largest robots in the world.

Figure 7 JET Telescopic Articulated Remote Manipulator

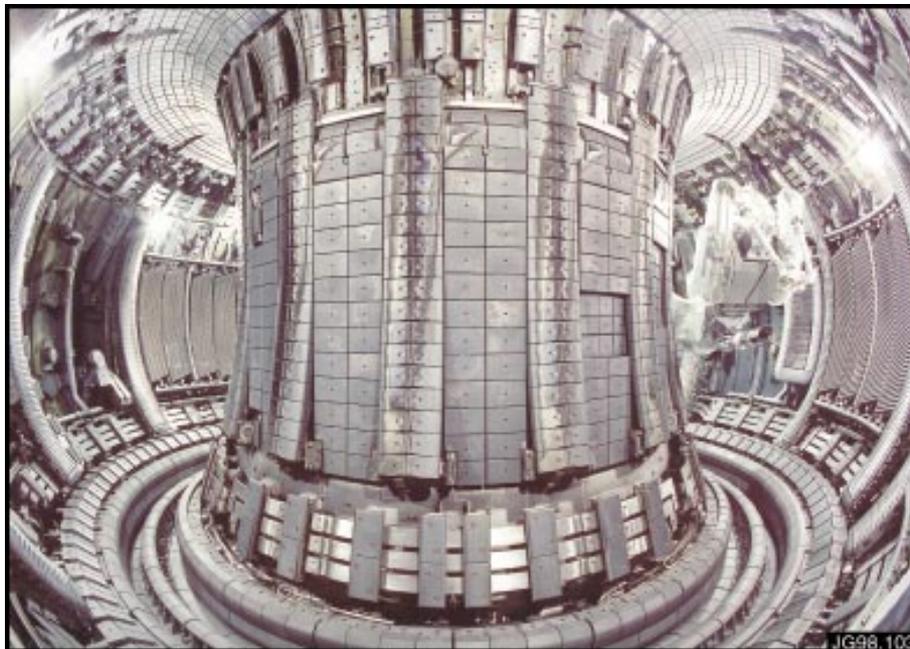
*Figure 8 Inside of JET Torus after modification - May 1998*

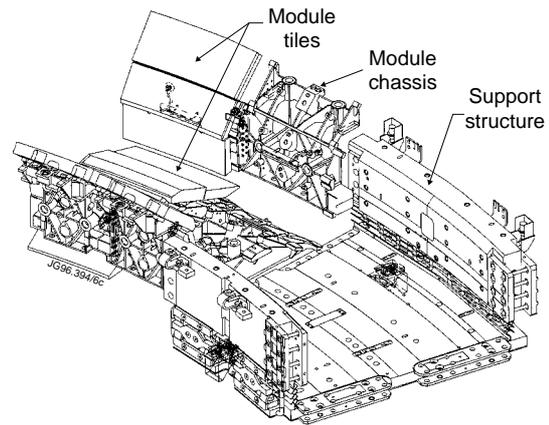
The MkIIa, divertor comprises a ‘U shaped water cooled mechanical structure onto which are bolted the 144 MkIIa divertor modules, figure.9. It was required to remove these and replace them with 192 MkIIgb divertor modules of similar size but different shape. The support structure incorporates dowel slots to ensure the precise alignment of divertor modules and also incorporates pre-wired electrical sockets into which diagnostics attached to the divertor modules can be remotely plugged. The divertor tile surfaces exposed to the plasma must be very accurately aligned in order to avoid creating hot spots during the energy transfer. For the same reason the tile surfaces and edges must not be damaged during installation.

Figure 9 JET MkIIa Divertor construction

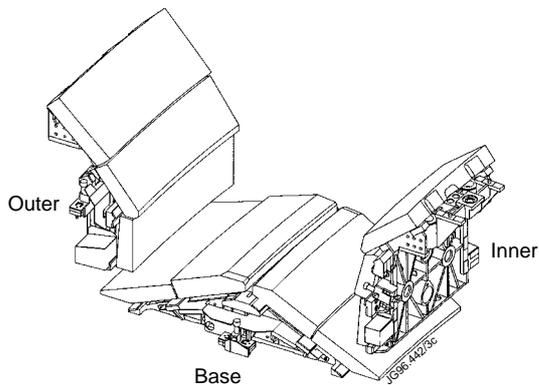
The MkIIa modules were arranged one each on the inner, outer and base surfaces of the divertor structure, figure.10.

Figure 10 MKIIa Divertor Modules

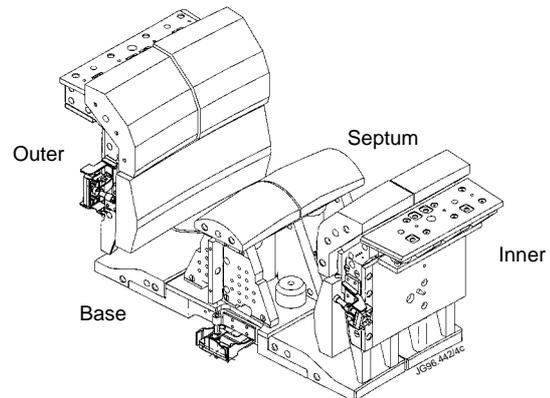
Figure 11 MkII Gas Box Divertor Modules

The MkII gas box divertor has four modules one each on the inner, outer and base surfaces of the divertor structure and an additional so-called Septum module which is bolted onto the base module, figure.11. The modules are aligned and bolted to the divertor structure in a similar way to the MkIIa. In addition to this primary task it was required to clean four Beryllium evaporators, vacuum clean dust and flakes from the divertor region, replace a number of small diagnostic components, inspect the torus protective tiles and undertake a full 3-dimensional survey of the divertor support structure to an accuracy of better than 1mm using digital videogrammetry techniques.

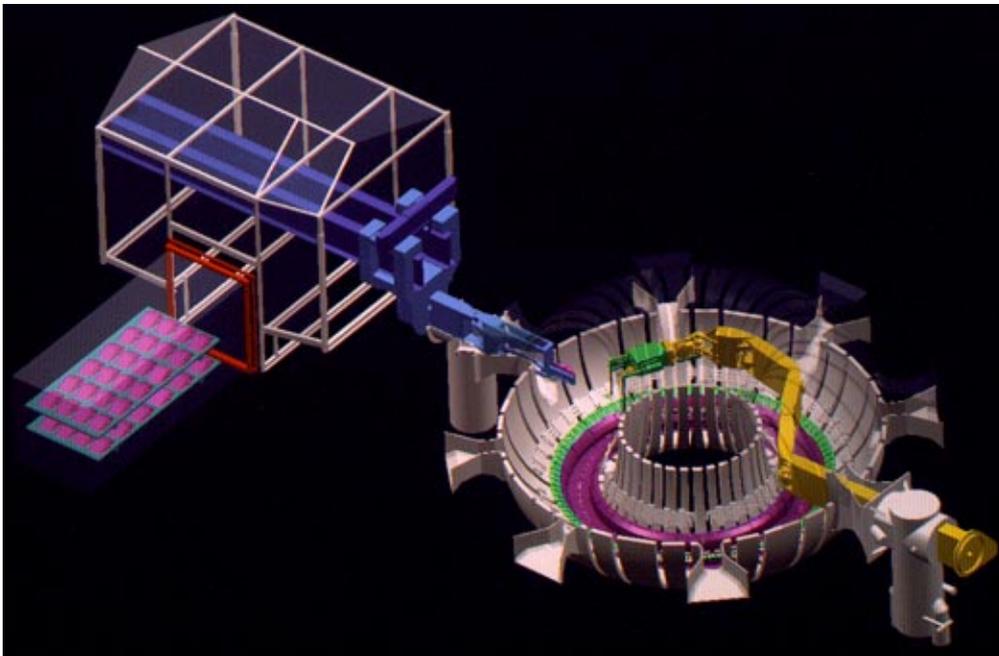
All in-vessel work was done fully remotely by means of the Mascot servo-manipulator /1/ transported into the torus through a rectangular access port by the JET Articulated Boom /2/, fig.12. All other equipment required inside the torus was transferred through a second port using a special end-effector mounted on a short articulated boom /3/. After removal the activated divertor modules were stored on trolleys within removable ISO cabins, fig.12.

*Figure 12 Overall remote operations scenario*
